Case Study: Wind Farm

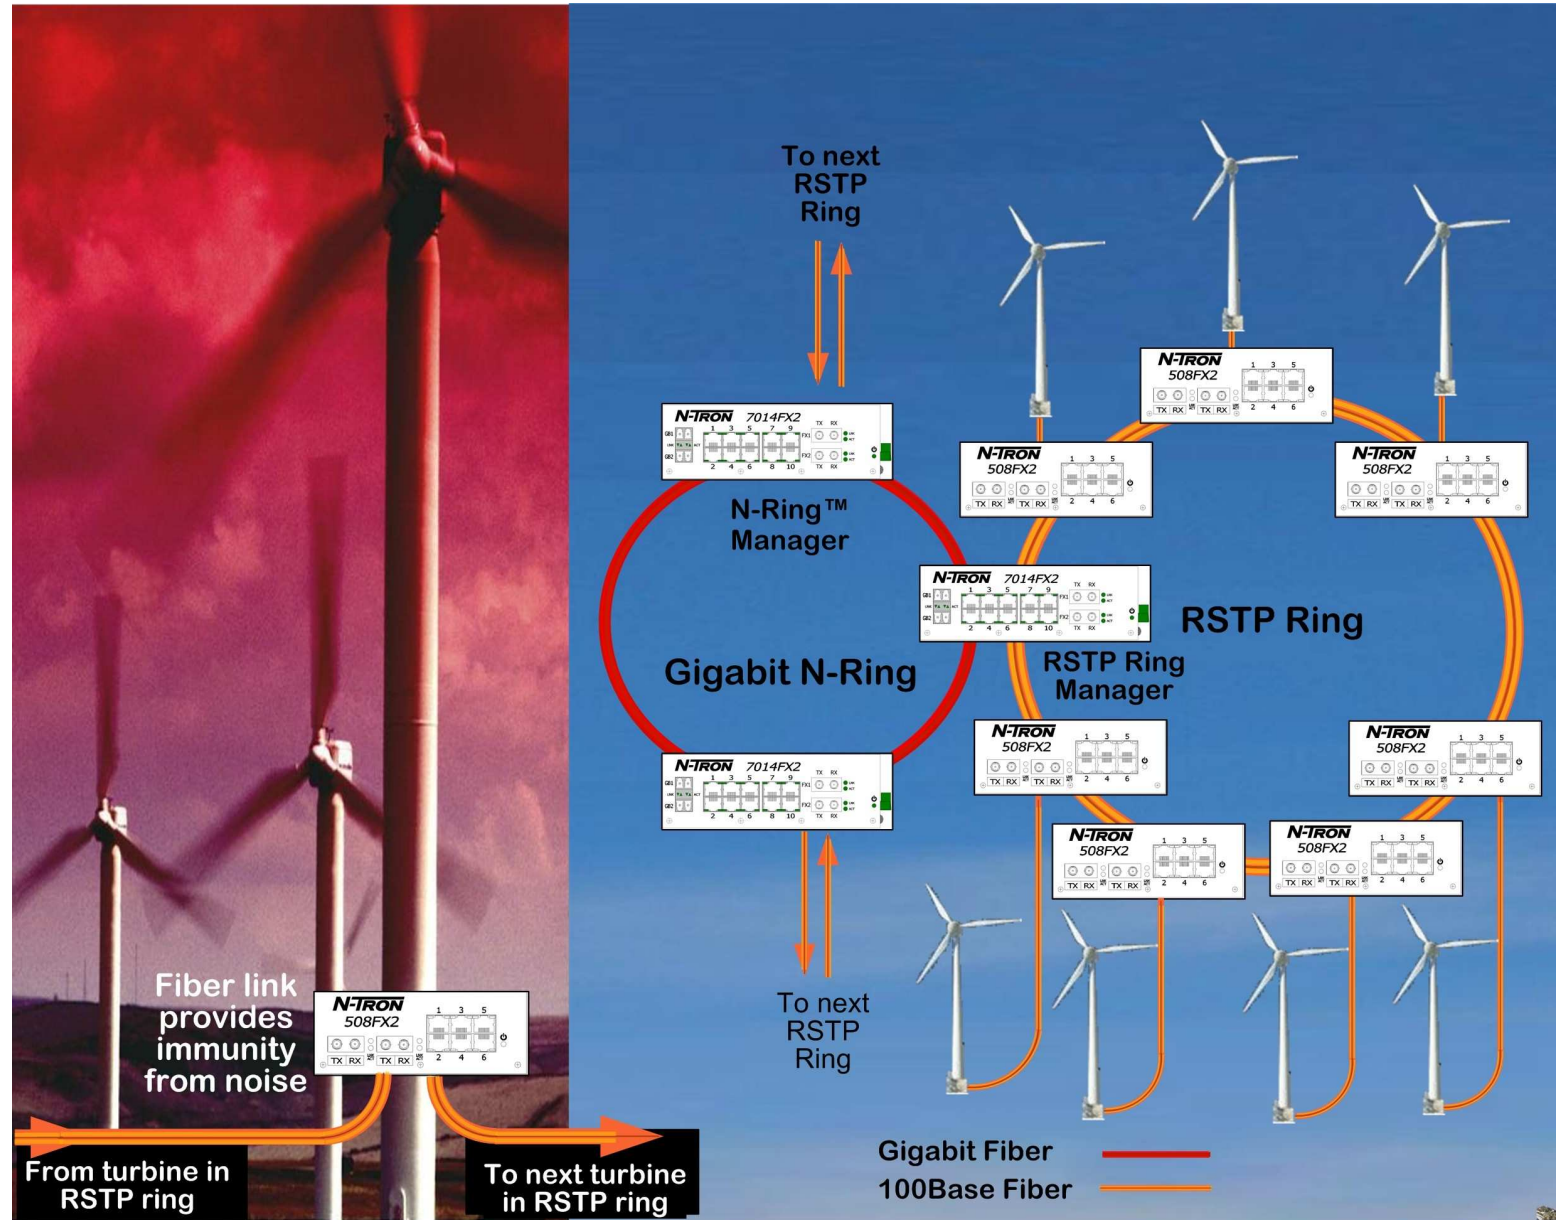
Topology for Wind Farm application

N-TRON's solution involved the use of a 7014FX2 fully managed switch as a ring manager, and 508FX2-A-ST switches at the individual windmills. Temperature related failures were eliminated due to the 7014FX2's temperature rating of -20°C to 70°C and the 508FX2's rating of -40°C to 85°C. Automatic IGMP snooping makes replacement or addition of switches a plug and play proposition, plus the N-TRON solution was 1/3 of the competition's cost.
